**Roca**

# ELEMENT

**A247704 - 1800x800**

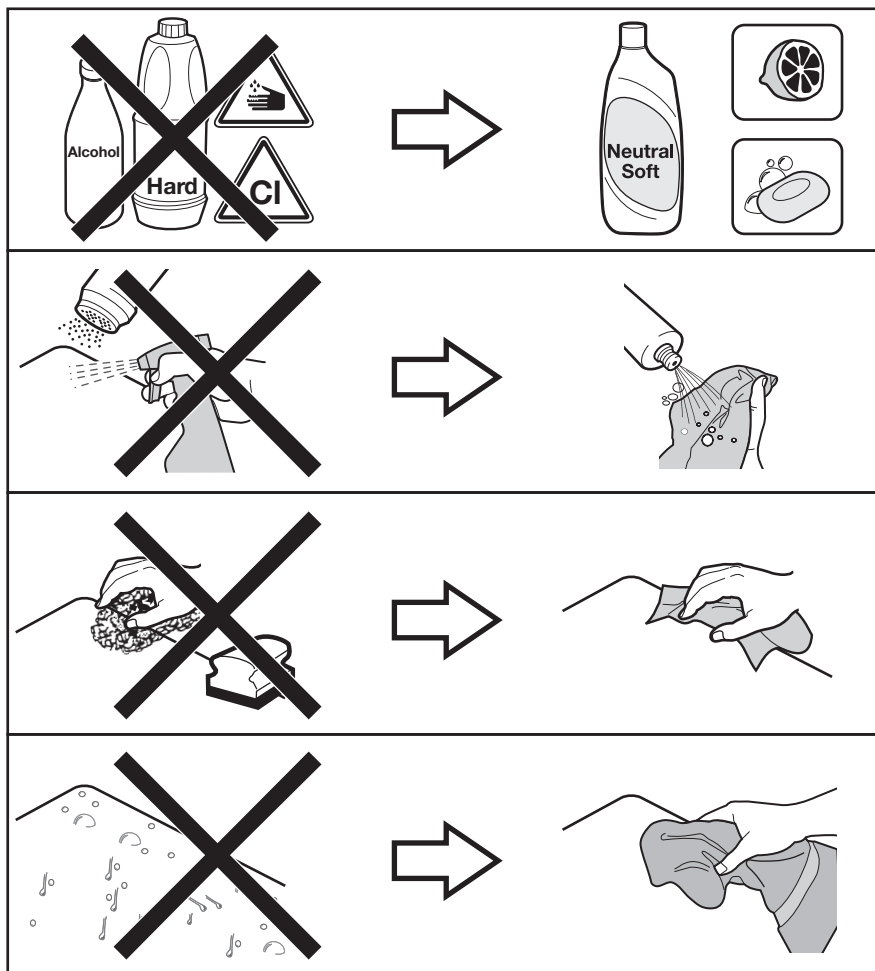
**9**

NO ACETIC

12 h
